Evaluation Report of Rust Grip Test Samples Hwy. 190 Mississippi River Bridge Located in Baton Rouge, LA

CorrTech Inc. 25 South Street Hopkinton MA 01748 CorrTech, Inc. Job No. 5223

September 2007

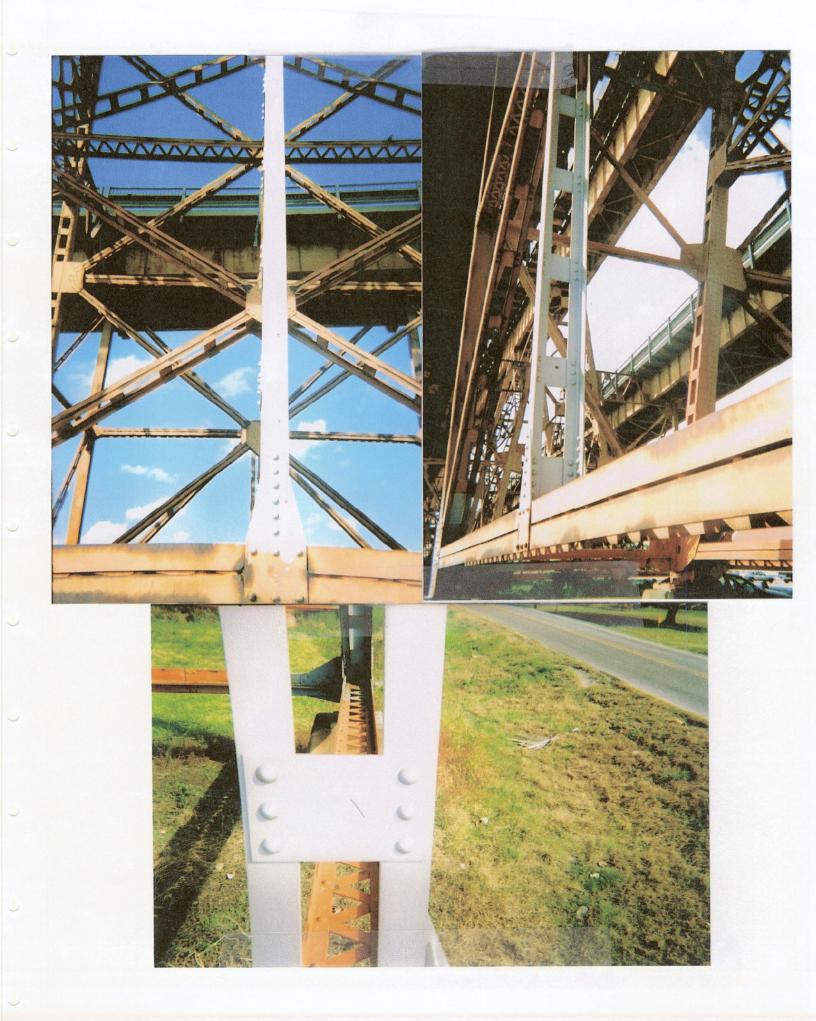
ASTM 610 Rust grade 9 M 714 Scale 10

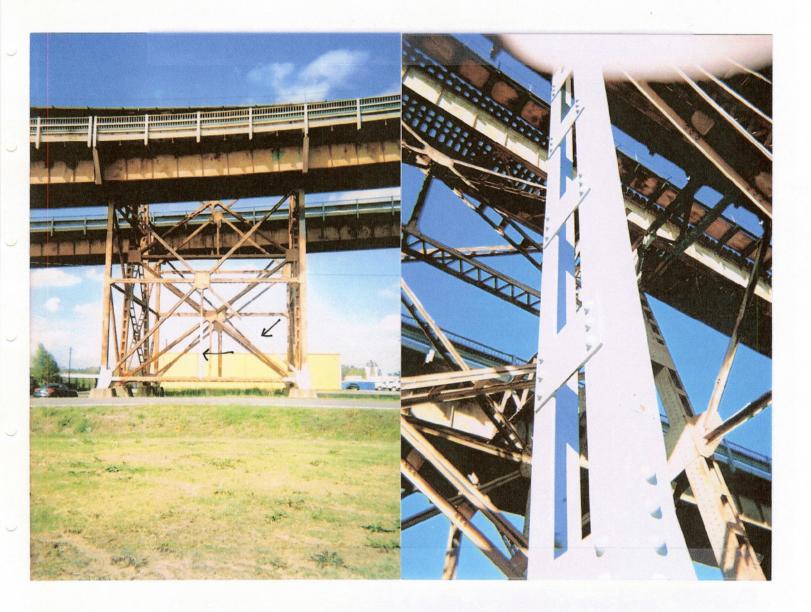
ASTM 610 Rust grade 10 M 714 Scale 10

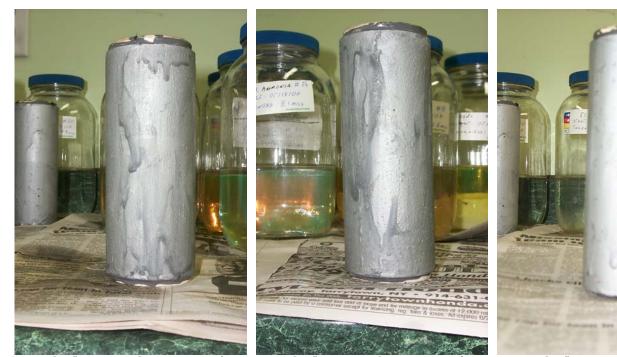
Sample #24 Exposed to 5% Ammonia

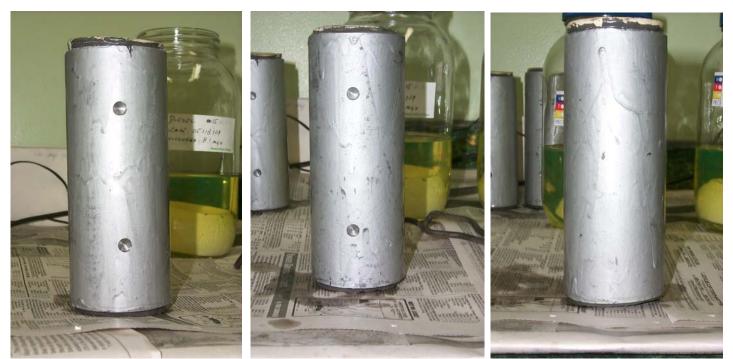
Sample #15 Exposed to Diesel
