# Mobile Phone Containers Vodaphone Turkey May 2008

#### Situation and Problem Definition.

## Test Results Turkey for July and August, 2007

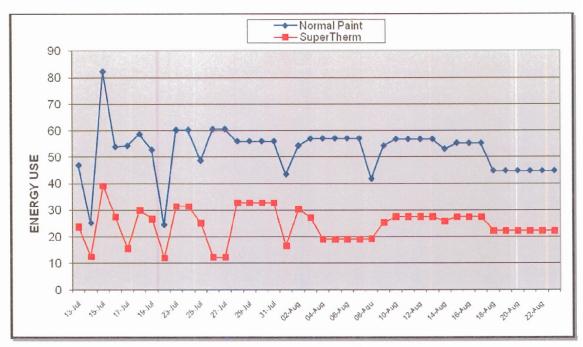
Graph 1: Energy use of containers: one with Super Therm® and one with normal white paint

Inside temperature of 23 degrees C was reached. An average energy saving of over 50% was achieved.
